# Performance studies on Coir Geotextiles in Pavements having Soft Soil Subgrade

Department of Civil Engineering  
College of Engineering Trivandrum  
Trivandrum- 695016  
**January 2015**

Project title: **“Performance study on Coir Geotextiles in pavements having soft soil subgrade”**

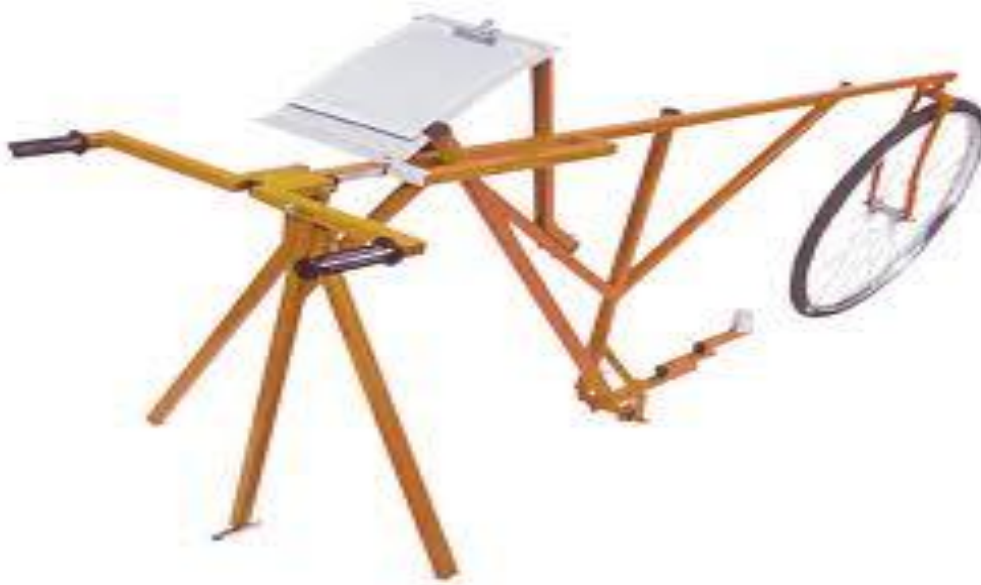
Fig.2.2 Photograph of Merlin test apparatus

Road surface roughness is an important measure of road condition. The Merlin road roughness measurement machine was developed by the Transport Research Laboratory for use in developing countries. Schematic sketch and photograph of Merlin are shown in figures 2.1 and 2.2

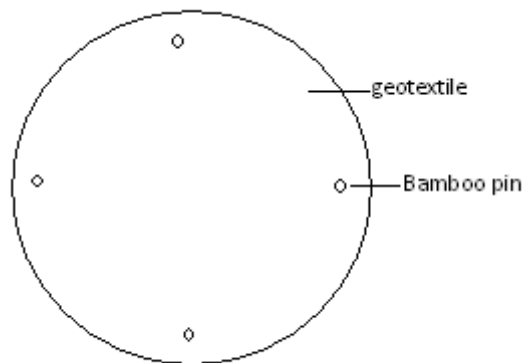
**Fig.3.2. Position of bamboo pins as anchorage**

The tests were also conducted on samples with coir geotextile anchored. Anchorage was done by means of bamboo pins of 2.5 cm long and a maximum of four pins were placed around the coir geotextile as shown in Fig .3.2.

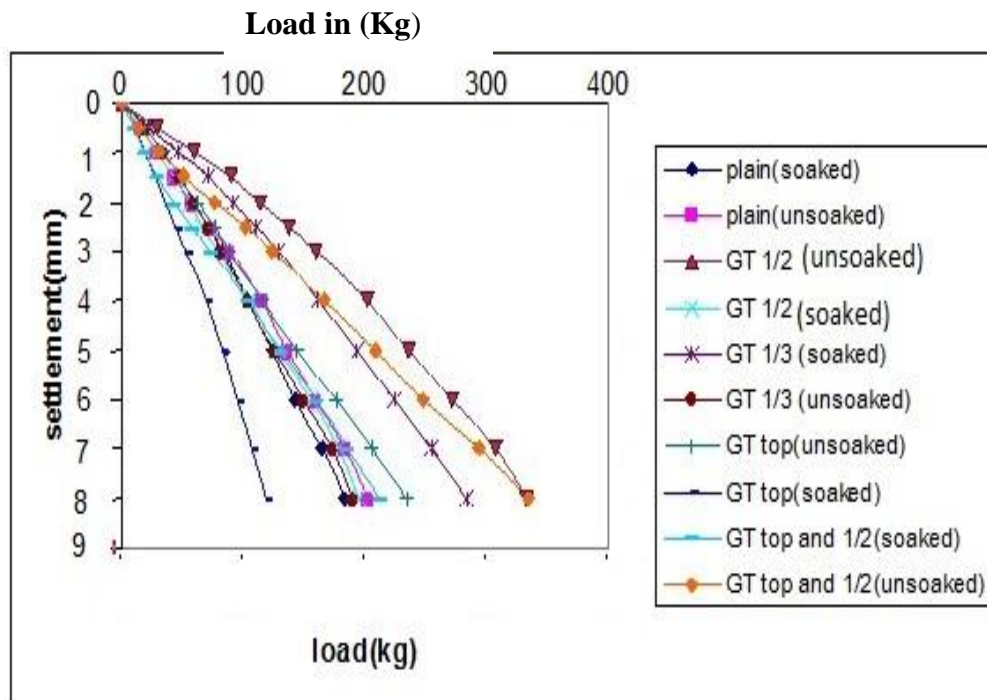
Fig.3.4.CBR test results of Varkala local soil

The results of CBR test conducted on Varkala local soil by placing geotextile at various depths are shown in Fig 3.4. No anchorage was provided.

From Table 4 it can be observed that the CBR values for soil reinforced with geotextiles shows a lower CBR value than that obtained for reinforced case in case of soaked soil. This decrease may be attributed to the slippage of the geotextile that takes place between the soil layers. In the field layer slippage doesn't happen. Hence anchors were provided and the CBR test was repeated.

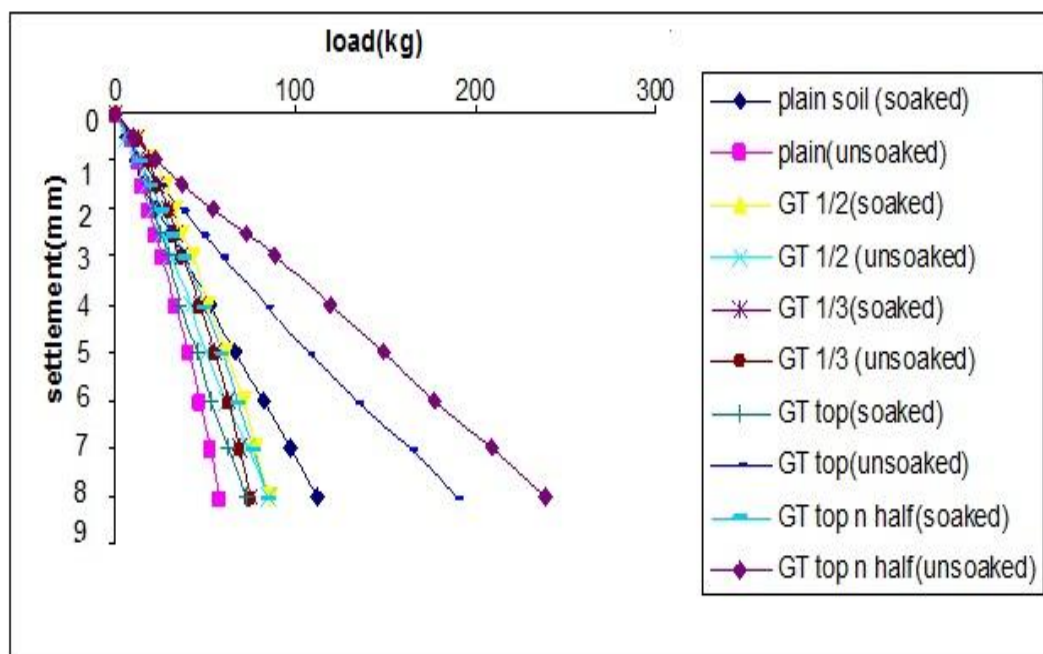
Fig.3.5. CBR Test results on Varkala local after anchorage was provided.

A series of same test were conducted after proper anchorage of geotextiles in soil layers using bamboo nails of 2.5 cm long. Fig.3.5. Shows the results of CBR tests conducted after providing proper anchorage to the geotextiles.

From Table 5 it was observed that a percentage increase of 122% was seen when two layers of geotextiles was placed at top and half the depth from top of the subgrade.

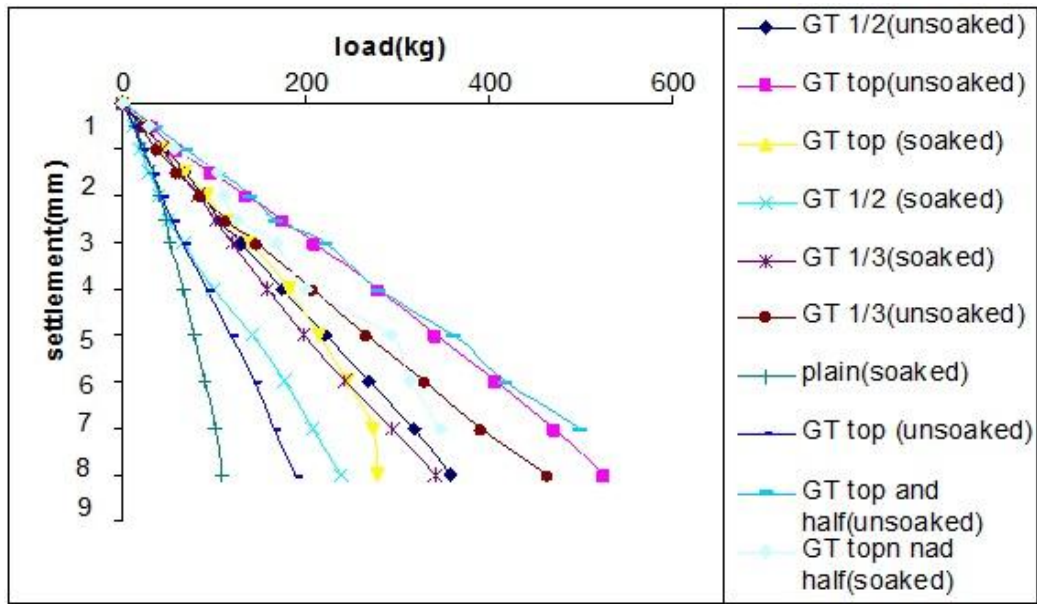
Fig.3.8. CBR Test results on Varkala Fill after anchorage was provided

A series of same test were conducted after proper anchorage of geotextiles in soil layers using bamboo nails of 2.5 cm long. Fig.3.8 shows the results of CBR tests conducted after providing proper anchorage to the geotextiles.

From table 7 it was observed that a percentage increase of 173% was seen when two layers of geotextiles was placed at top and half the depth from top of the subgrade.

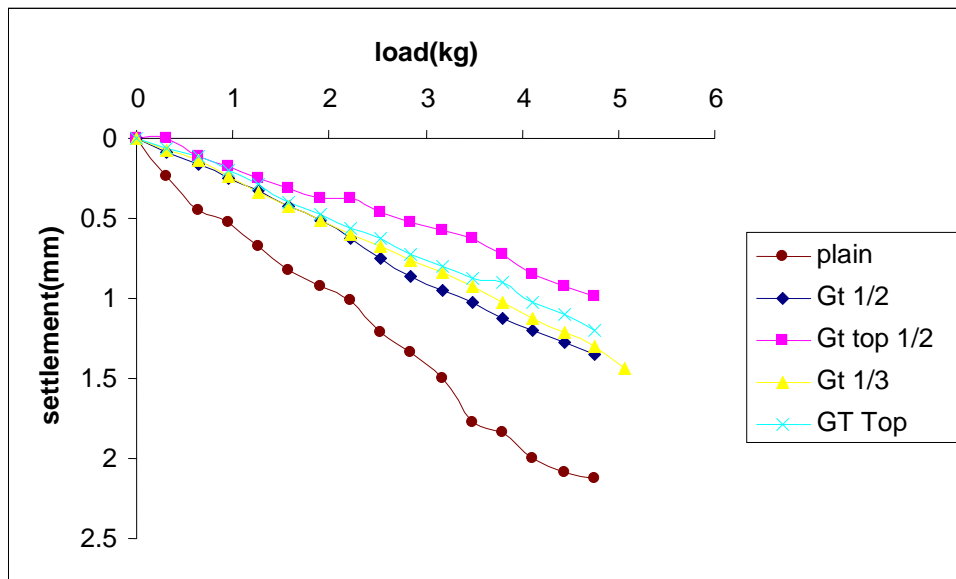
Fig.3.9. Plate load test results of Varkala Fill soil

The results of plate load test conducted on Varkala Fill soil by placing geotextile at various depths are shown in Fig.3.9

From the graph it can be observed that the bearing capacity of soil improves when the geotextiles is placed at top and at 10 cm from top of the subgrade.

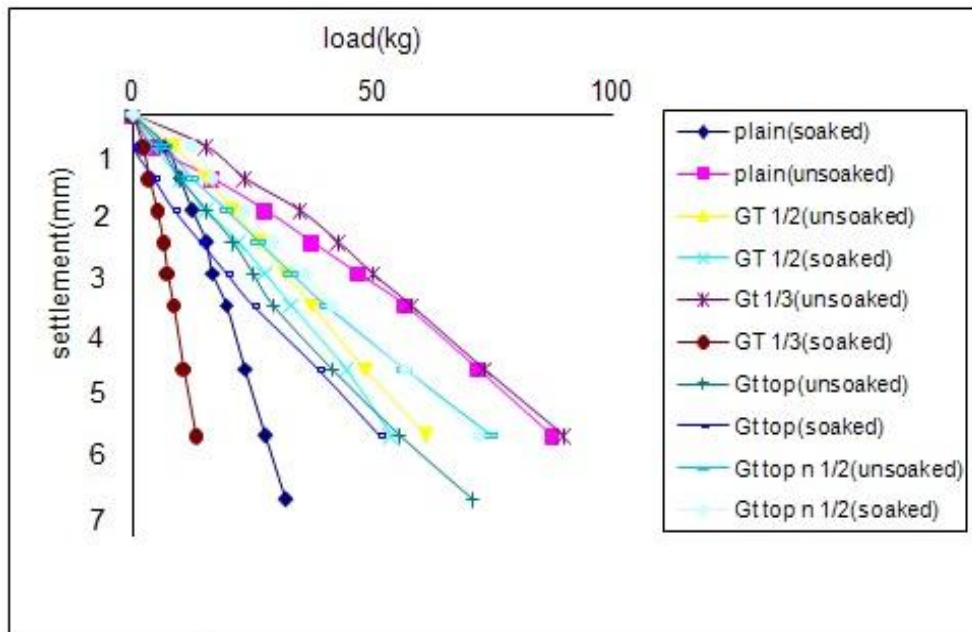
Fig.3.10. CBR Test results on Kozhinada Local soil.

The results of CBR test conducted on Kozhinada Local soil by placing geotextile at various depths are shown in Fig 3.10.

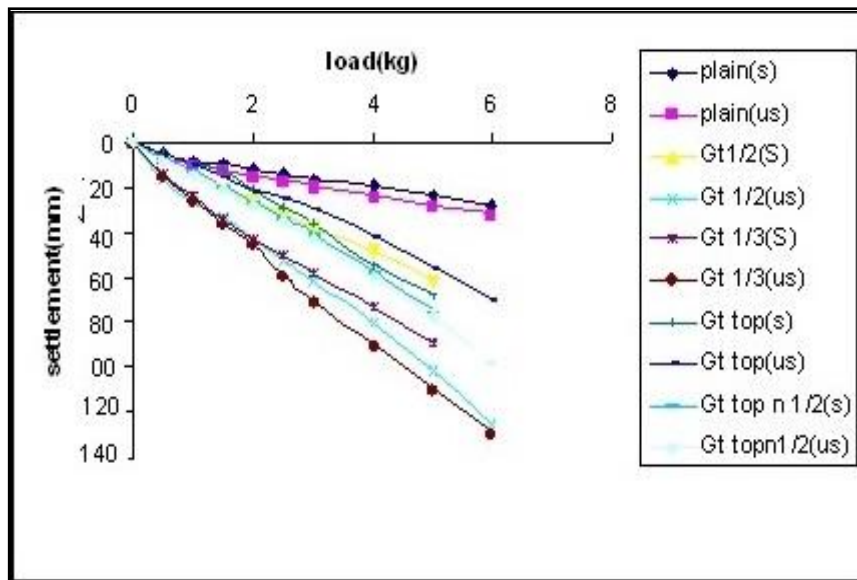
Fig.3.11. CBR Test results on Kozhinada Local after anchorage was provided

A series of same test were conducted after proper anchorage of geotextiles in soil layers using bamboo nails of 2.5 cm long. Fig .3.11 shows the results of CBR test conducted after proving proper anchorage to the geotextiles.

From Table 8 it was observed that an increase of 307% was seen when the geotextiles was placed at top and half the depth from the top of the subgrade.

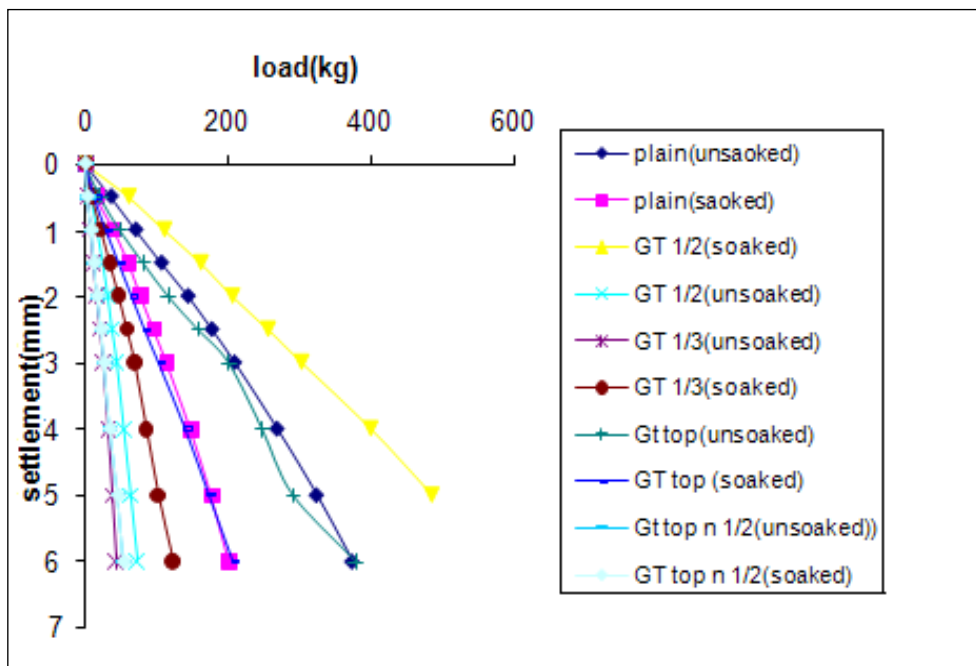
Fig.3.13. CBR Test results on Kozhinada Fill soil

The results of CBR test conducted on Kozhinada Fill soil by placing geotextile at various depths are shown in Fig.3.13.

From Table 10 it can be observed that the CBR values for soil reinforced with geotextiles shows a lower CBR value than that obtained for reinforced case. This decrease may be attributed to the slippage of the geotextile that takes place between the soil layers.

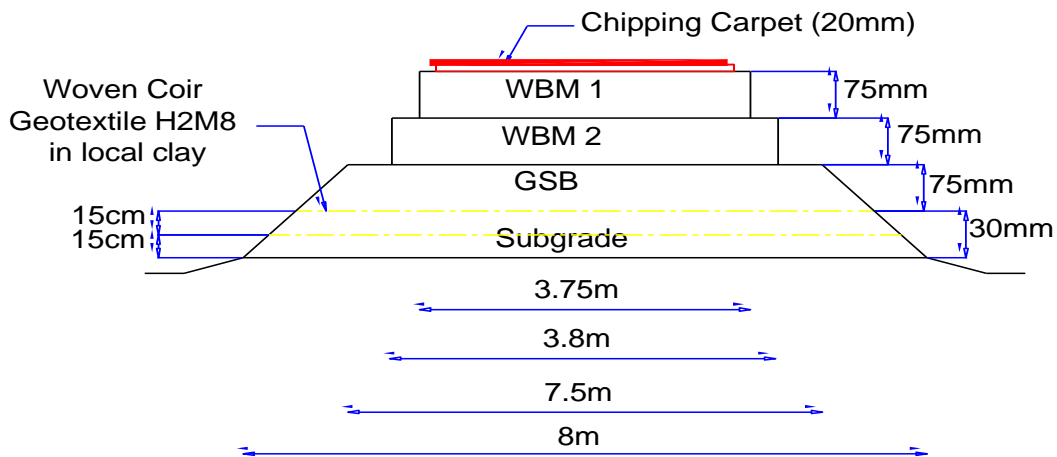
Fig .4.4. Cross Section H4

Coir reinforcement are providing at the top and 15cm from the top of locally available clay material as shown in Fig.4.4.

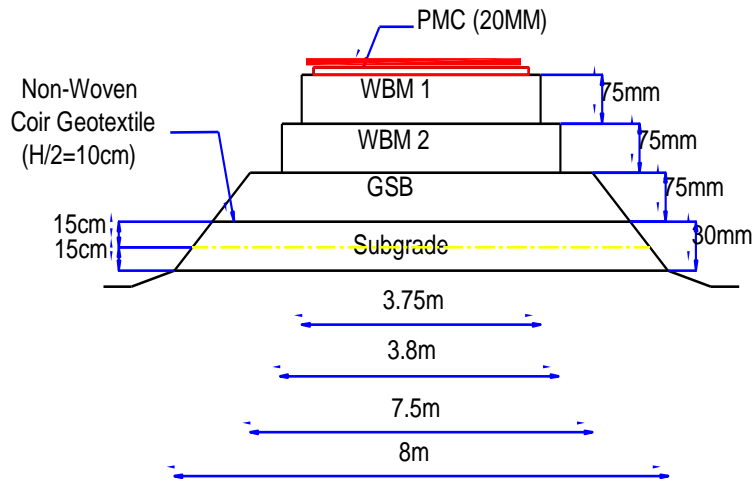
Fig .4.7. Cross Section V3

Coir reinforcements are placed at a depth of  $h/3$  from top of subgrade.  $h/3 = 300/2 = 150$ mm as shown in Fig.4.7.

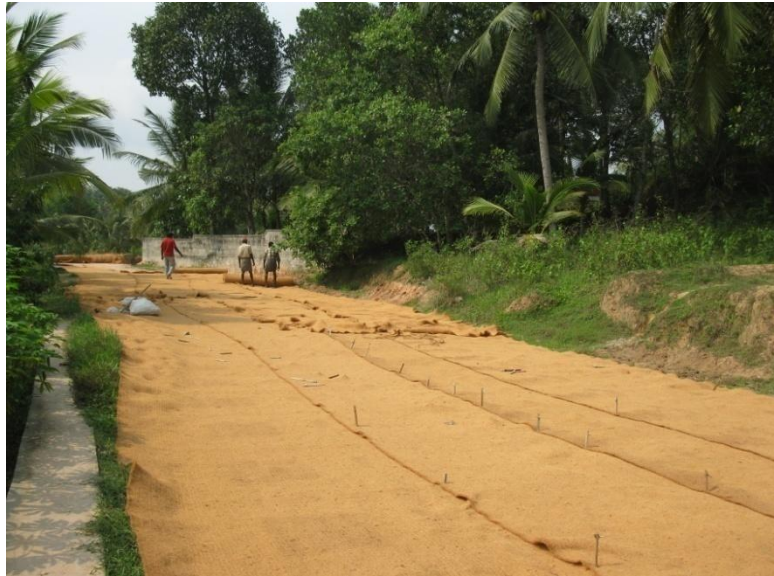
Fig. 3 Laying of coir geotextile in Kozhinada

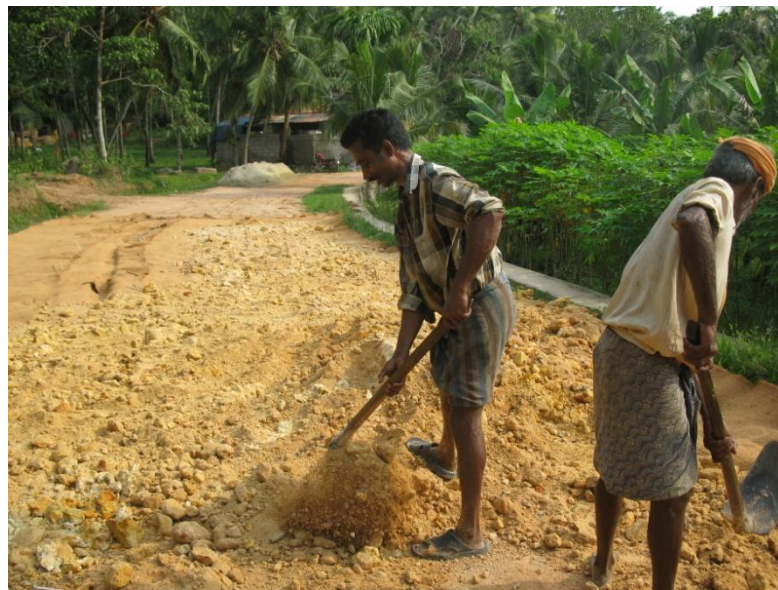
Fig. 4 Placing of soil above geotextile in Kozhinada

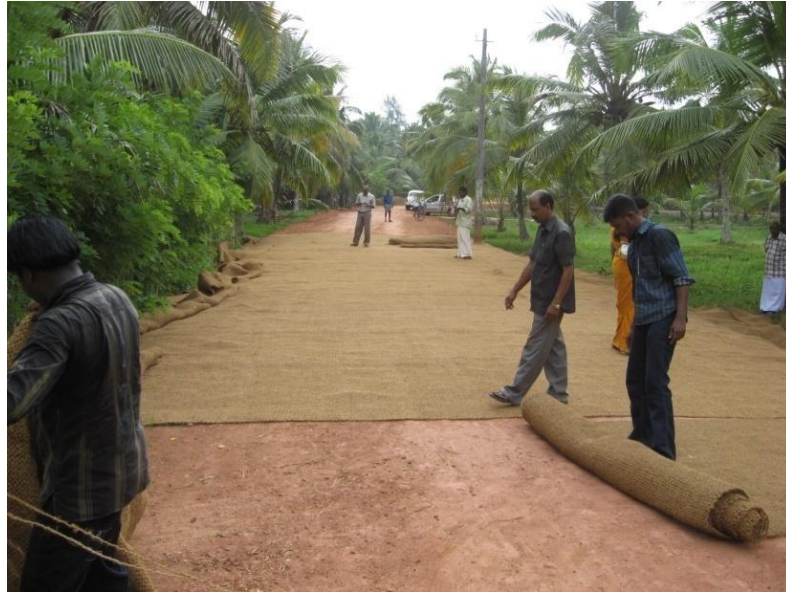
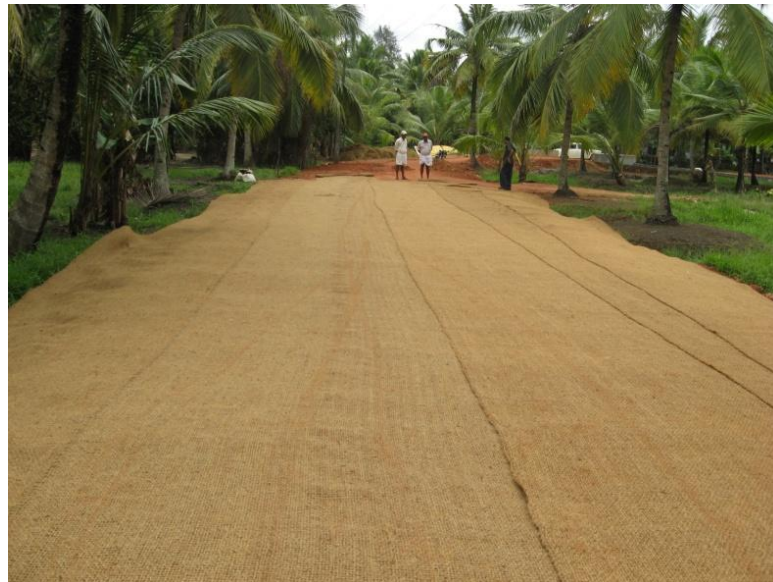
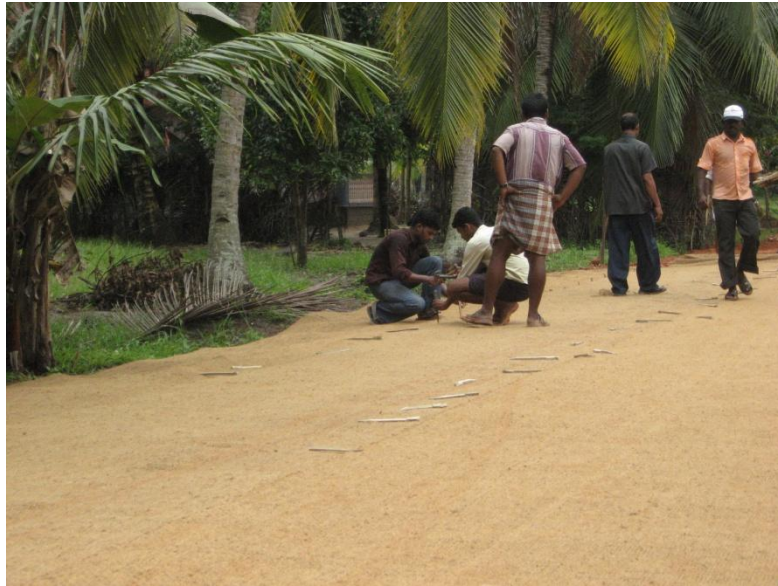
Fig. 1 Placing of coir geotextile – Mangalabharathy SN Kadavu road in Haripad

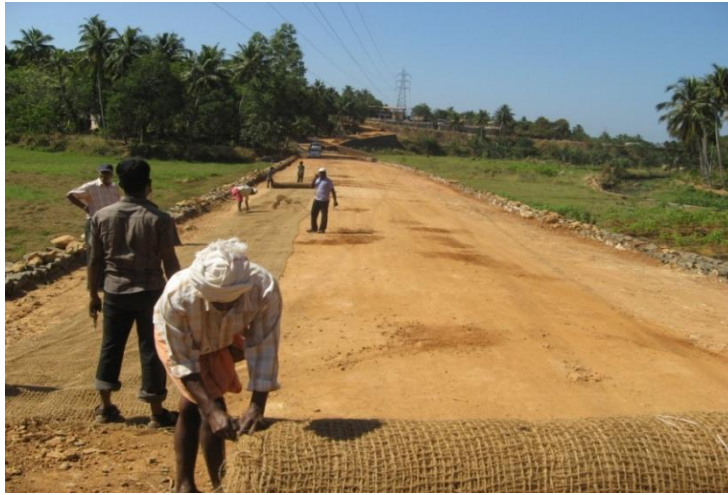
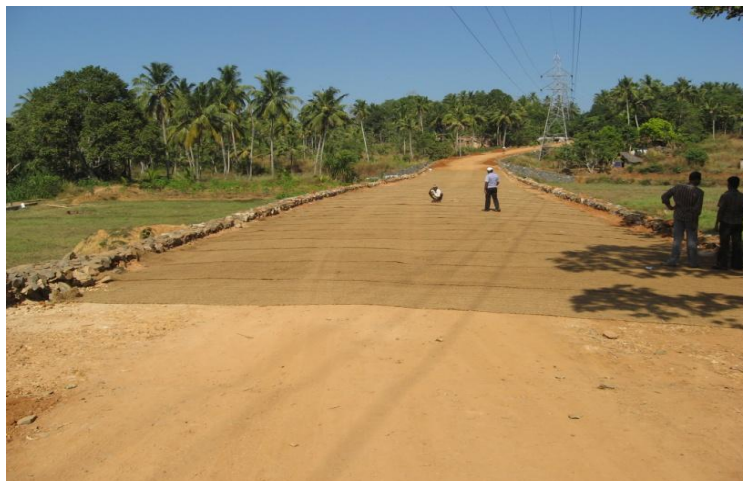
Fig. 1 Laying of coir geotextile in Chirakkad- Kumbakkad road (Varkala)

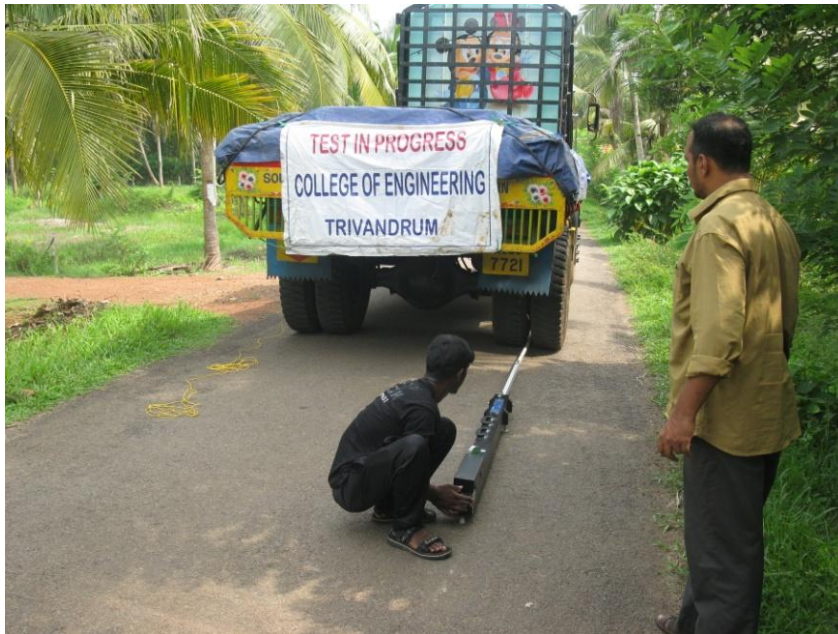
Benkelman Beam test in progress

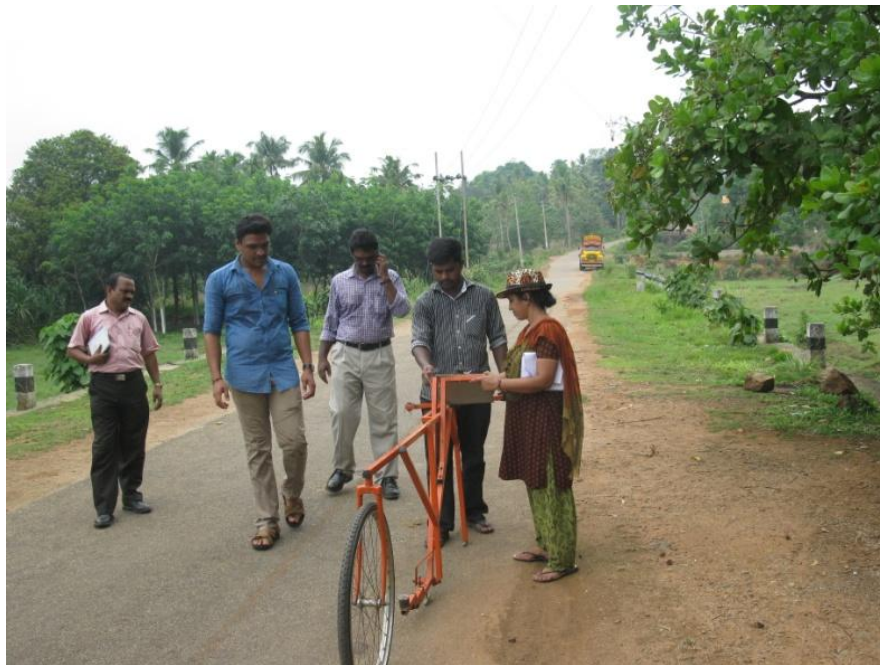
Merlin test in progress
